Manhole Inspection Summary

Manhole # S33AA1031MH

Insp Date: **10/22/08 2:55 PM**

Location Address: **3404 SAINT PAUL ST**

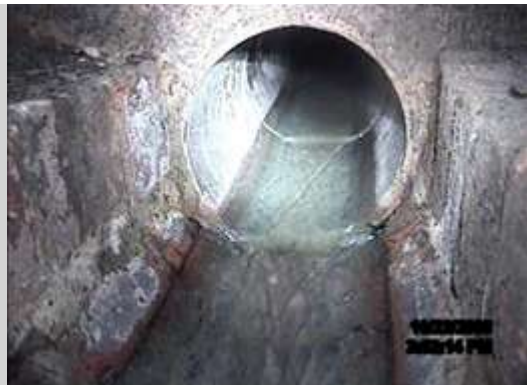
8 in. Circular Gravity Sewer Pipe In @ 6 O'Clock

Rod and Bar (Angled)

Pipe Material: **Clay** ☐ Pipe Lined

Infiltration: **None** Pipe Seal Cond: **Unknown**
